Manhole Inspection Summary

Manhole # S39CC1010MH

Insp Date: **12/15/06 2:08 PM**

Location Address: **721 37TH ST**

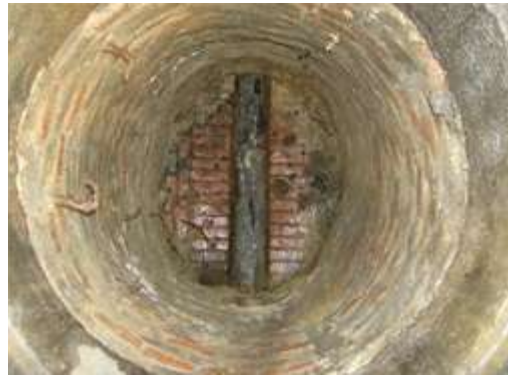
Top View

Bench ☒ Exists Material: **Brick** ☐ Parged ☒ **Debris** (not Condition related)

Steps Count: **3** Missing: **3** ☒ **Corroded**

Corroded and missing steps. Bench debris.

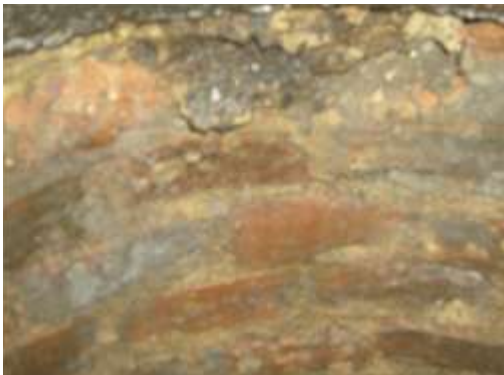
Defect

Frame Offset: **0** (in.) Condition: ☐ Sound ☐ Cracked ☒ **Leaks**

Condition: ☐ Sound ☐ Cracked ☐ Root Intrusion ☐ Loose Brick ☒ **Deteriorated**

Infiltration: ☐ None ☒ **Joint** ☐ Cracks ☐ Mortar ☐ Roots ☒ **Wall**

Frame leaks. Adjustment deterioration and infiltration.

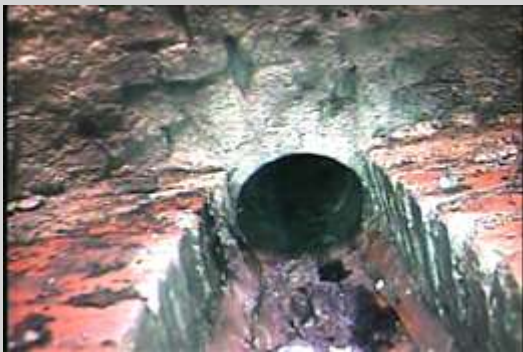
8 in. Circular Gravity Sewer Pipe Out @ 12 O'Clock

Infiltration: **None** Pipe Seal Cond: **Unknown**

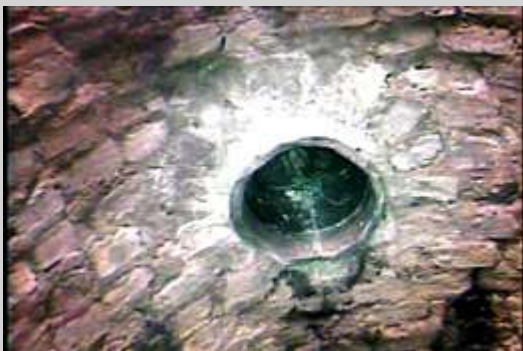
8 in. Circular Gravity Sewer Pipe In @ 6 O'Clock

Infiltration: **None** Pipe Seal Cond: **Broken**

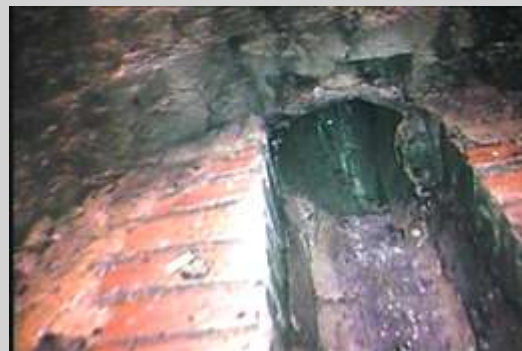
Drop In @ 6 O'Clock

Drop: **Outside** Rod and Bar

Drop Condition: **Open**
